# C P Home Inspections

## Sample Inspection Report

Client(s): **Happy Homer**  
Property address: **1234 Inspection Drive,  
Healthy Home, WA 9836X**  
Inspection date: **Thursday, June 25, 2015**

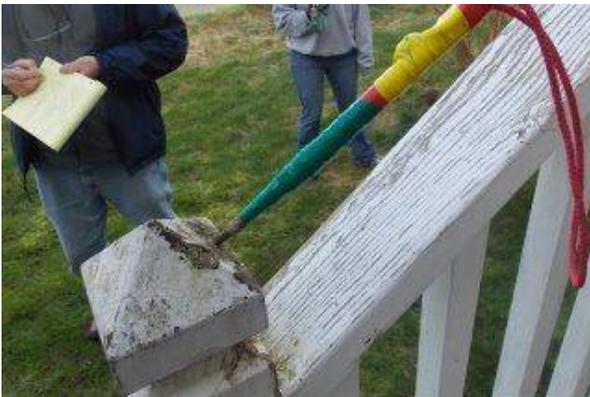
**Photo 1-1**

Fungal rot was found at front guardrail stair areas (see photo) . Recommend that a qualified person evaluate and repair as necessary. All rotten wood should be replaced.

Post cap rotten, front deck.

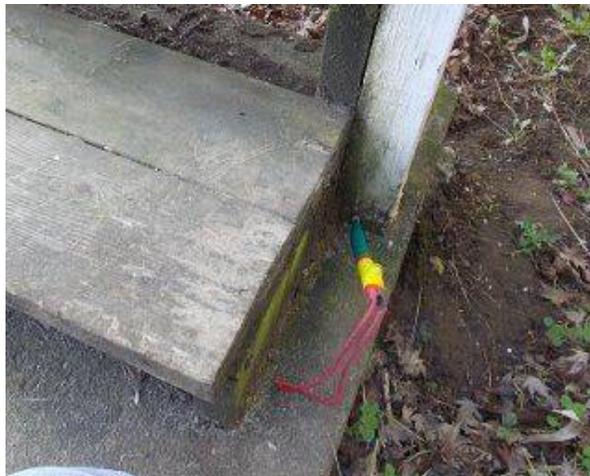
**Photo 1-2**

Front stairs post and handrail areas

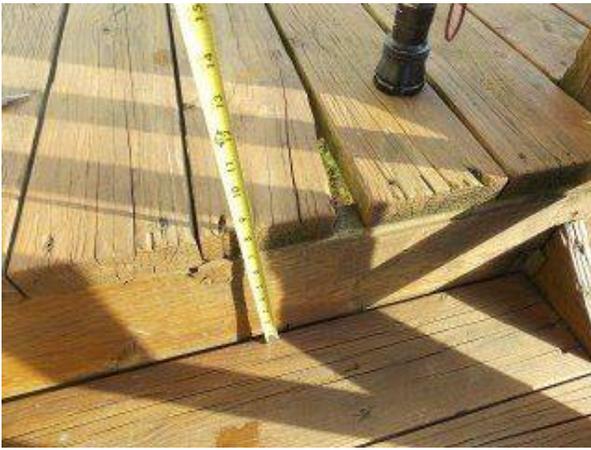
Risers at rear deck were higher than 7 3/4 inches and posed a fall or trip hazard. Risers should be 7 3/4 inches or shorter. At a minimum, be aware of this hazard, especially when guests who are not familiar with the stairs are present. Recommend that a qualified contractor repair per standard building practices.

**Photo 2-1**  
Last step onto rear deck is 8 1/2"

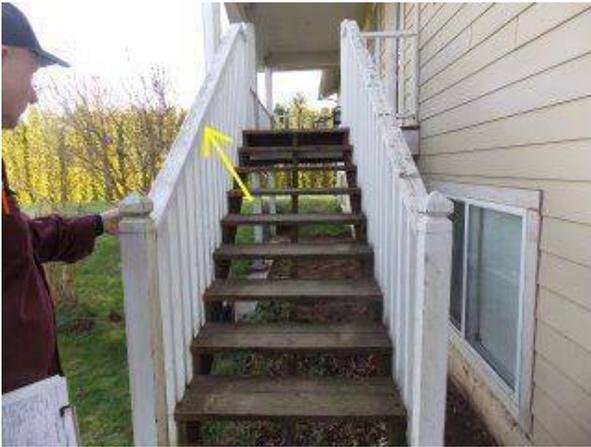
Handrails at front and rear flights of stairs were not graspable and posed a fall hazard. Handrails should be 1 1/4 - 2 inches in diameter if round, or 2 5/8 inches or less in width if flat. Recommend that a qualified person install graspable handrails or modify existing handrails per standard building practices.

**Photo 3-1**  
No graspable handrail front deck

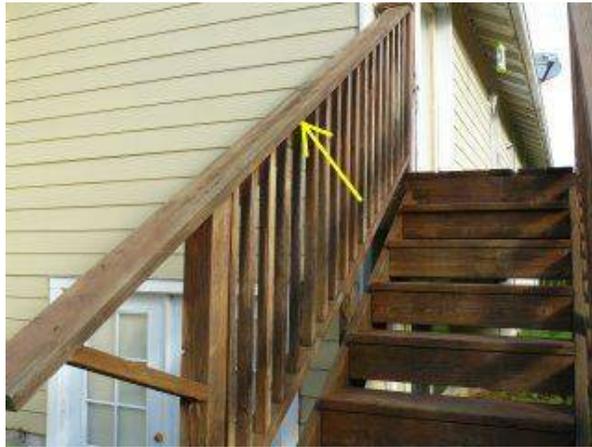
**Photo 3-2**  
No graspable handrail rear deck.

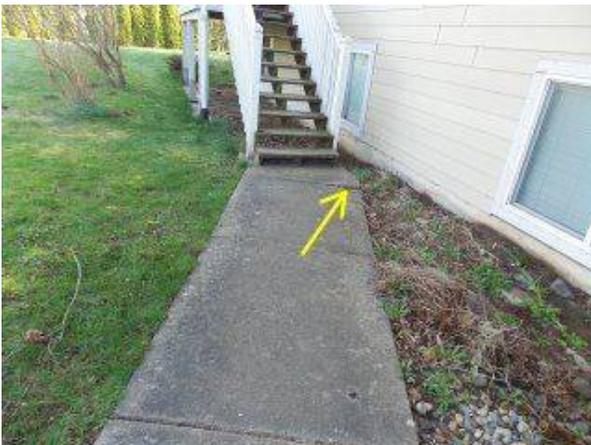
**Photo 4-1**

Front sidewalk has settlement, heaving and/or deterioration resulting in a trip hazard. For safety reasons, recommend that a qualified contractor repair as necessary to eliminate trip hazards or at least consider painting it orange or yellow to help warn of possible trip hazards.

Possible trip hazard at front (west) sidewalk.

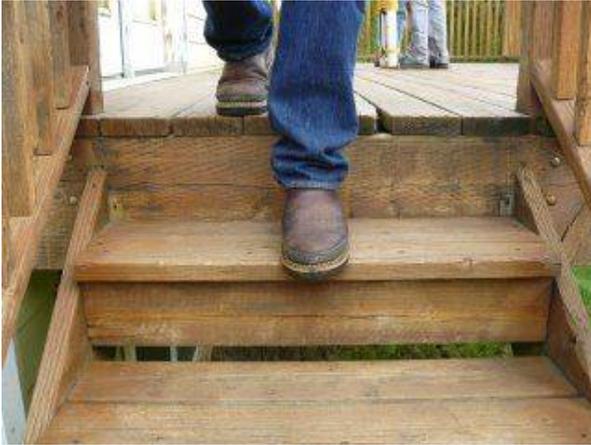
**Photo 5-1**

One or more treads at exterior rear deck stairs are loose. This is a potential fall hazard. Recommend that a qualified person repair as necessary.

Loose steps at rear (east) deck stairs

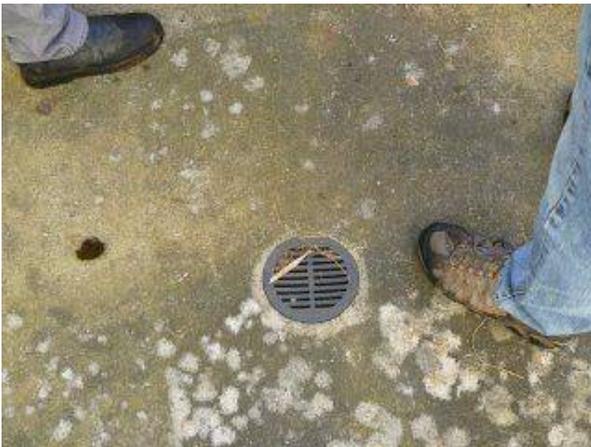
**Photo 7-1**

The condition of the drain at the base of the rear ( Northwest) concrete stairs is unknown. It's beyond the scope of a home inspection to determine if these drains flow adequately during prolonged periods of heavy rain. Recommend consulting with the property owners about this if possible, and monitoring drains in the future. If water is found to accumulate, then recommend that a qualified contractor evaluate and repair as necessary. For example, by cleaning, repairing or installing drains.

Rear entry to daylight basement concrete slab at basement floor level. Monitor

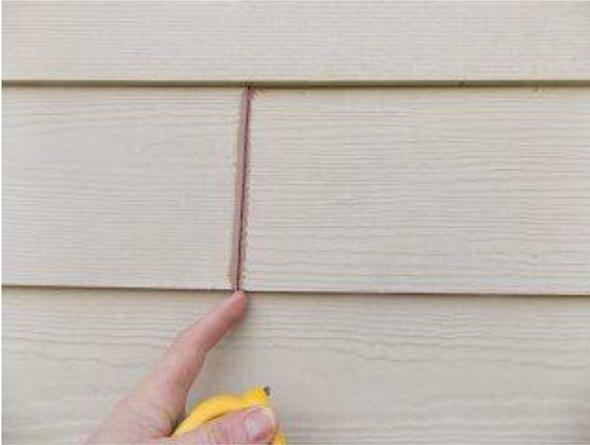
Exterior of home siding needs caulking and paint. It appears there is only primer on new lap siding. Recommend a licensed and qualified contractor do additional assessment and caulk and paint as necessary.

**Photo 8-1**  
Caulking failing and needs painting

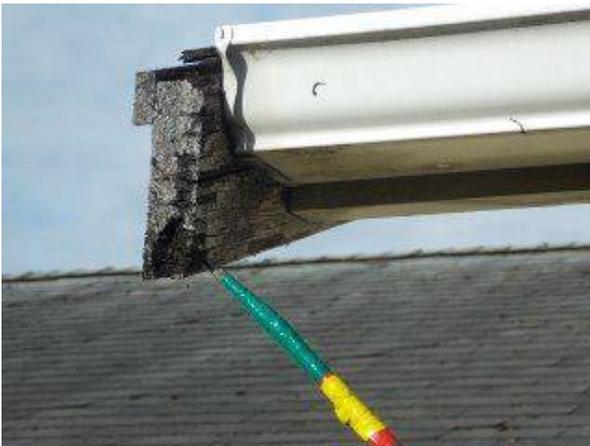
Areas of the roof barge board tails are uncovered or too close to the roofing surface. This is a conducive condition for wood-decaying organisms and should be corrected. Wood should be at least 2" off weather surfaces. Recommend a licensed and qualified contractor do additional assessment and replace or repair all rotten areas.

**Photo 9-1**  
Rotten barge tails.

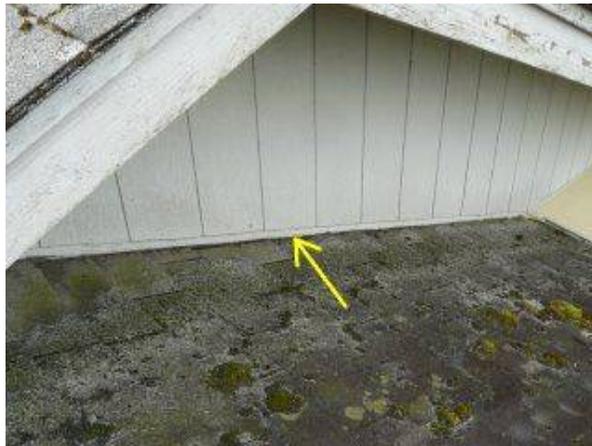
**Photo 9-2**  
This condition is conducive to wood decaying fungi or wood destroying organisms

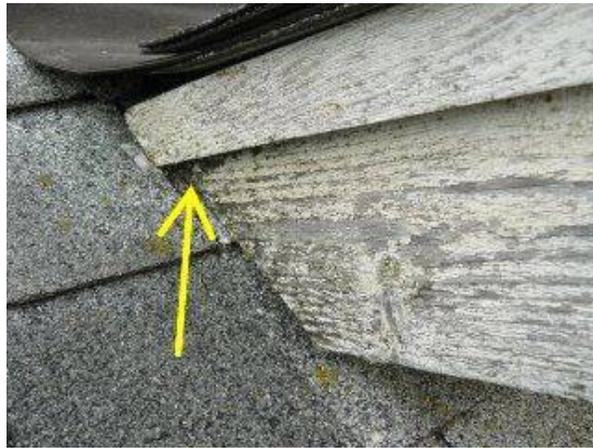
**Photo 9-4**

This condition is conducive to wood decaying fungi or wood destroying organisms

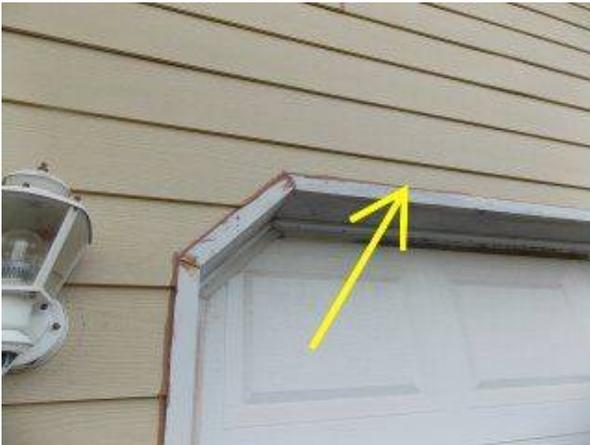
**Photo 10-1**

Drip or head flashings at doors and windows is missing. Leaks can occur as a result. Recommend that a qualified person repair, replace or install flashing as necessary, and per standard building practices.

No head flashings present at doors and windows.

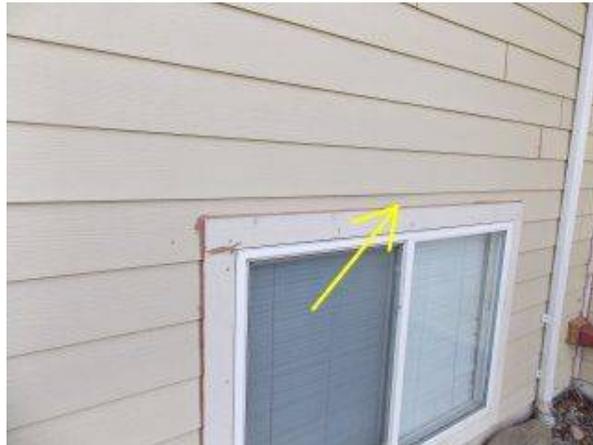
**Photo 10-2**

No head flashings present at doors and windows.

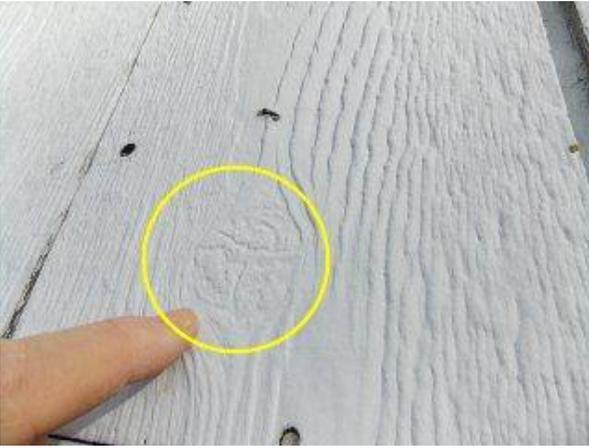
This property gable ends were clad with composition wood-fiber siding. Louisiana Pacific, have produced this type of siding, which is made from oriented strand board (OSB) or "hardboard." It is prone to deteriorate and/or fail prematurely due to moisture penetration, especially when the paint coating is substandard or has not been maintained. Failure is typically visible in the form of swelling, cracking, buckling, wafer pops, delamination and fungal growth.

**Photo 11-1**  
LP mark

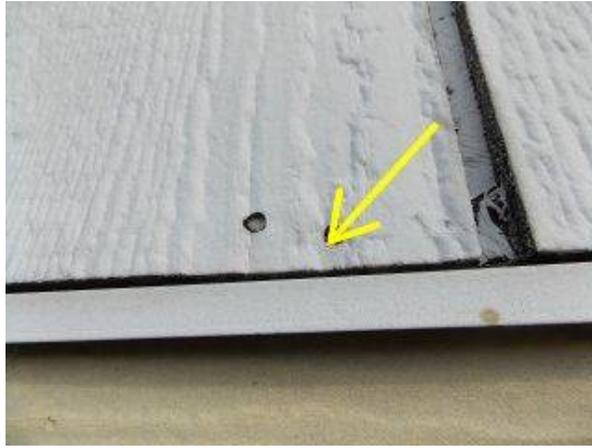
Some areas of siding on this structure showed symptoms described above and need replacement and/or maintenance. Some manufacturers (e.g. Louisiana Pacific) recommend a repair process for this siding where affected areas are sealed with a quality flexible primer, followed by two coats of 100% acrylic latex paint. This sealant must be applied to the bottom edges using a brush. The face of the siding can be sprayed. The Permanizer Plus sealer isn't required for edges that aren't swollen, cracked or deteriorated, but the acrylic latex should still be brushed on these edges.

**Photo 11-2**  
LP swelling.

Recommend that a qualified contractor evaluate and replace siding as necessary, and/or seal and repaint as necessary. Repairs should be made per the siding and/or sealant manufacturer's installation instructions, and per standard building practices.

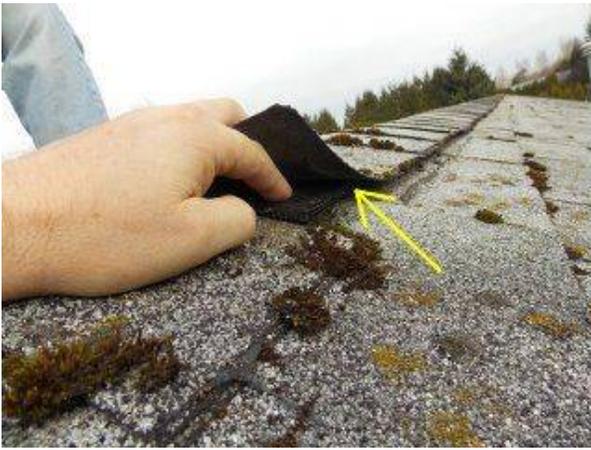
The roof surface appeared to be heavily worn, has inadequate ventilation and is near the end of its service life and will likely need replacing in the near future. There is also heavy moss buildup. Recommend additional venting and discussing replacement options with a qualified contractor, and budgeting for a replacement roof surface in the near future.

**Photo 12-1**  
Low profile ridge vent could be a cause of lack of attic ventilation.

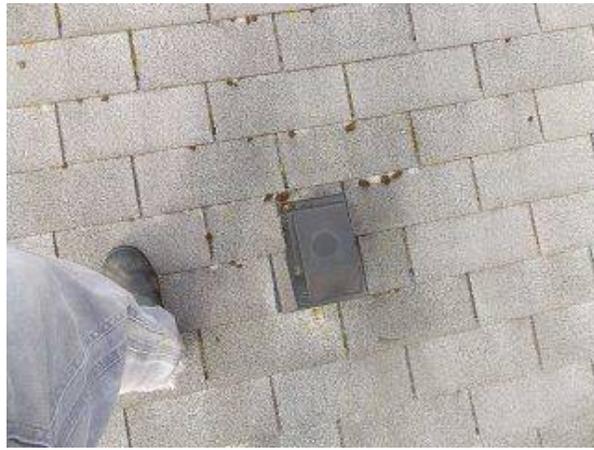
**Photo 12-2**  
Asphalt shingles aggregate worn heavily.

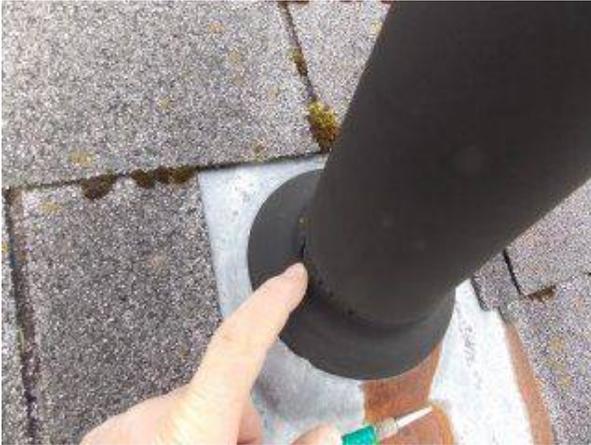
The rubber or neoprene pipe flashings were split or cracked. Leaks can occur as a result. This is a conducive condition for wood-destroying organisms. Recommend that a qualified contractor replace flashings where necessary.

**Photo 13-1**  
Rubber flashings split and causing possible water intrusion.

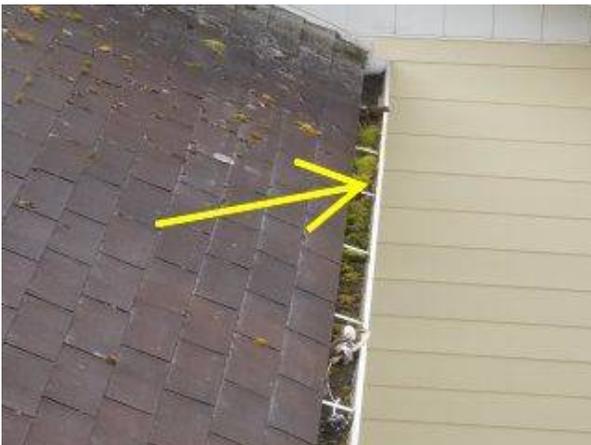
**Photo 14-1**

Significant amounts of debris have accumulated in one or more gutters or downspouts. Gutters can overflow and cause water to come in contact with the building exterior, or water can accumulate around the foundation. This is a conducive condition for wood-destroying organisms. Recommend cleaning gutters and downspouts now and as necessary in the future.

Gutters mostly full of moss, leaves and debris

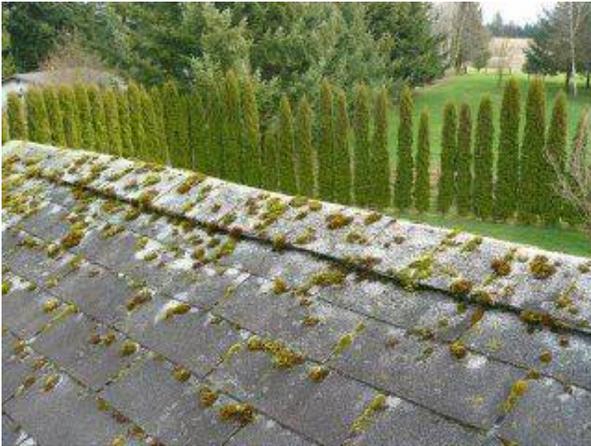
**Photo 15-1**

Moss was growing on the roof. As a result, shingles can lift or be damaged. Leaks can result and/or the roof surface can fail prematurely. Efforts should be made to kill the moss during its growing season (wet months). Typically, zinc or phosphate-based chemicals are used for this and must be applied periodically. For information on various moss treatment products and their pros and cons, visit:

Many areas of the roof have heavy moss buildup.

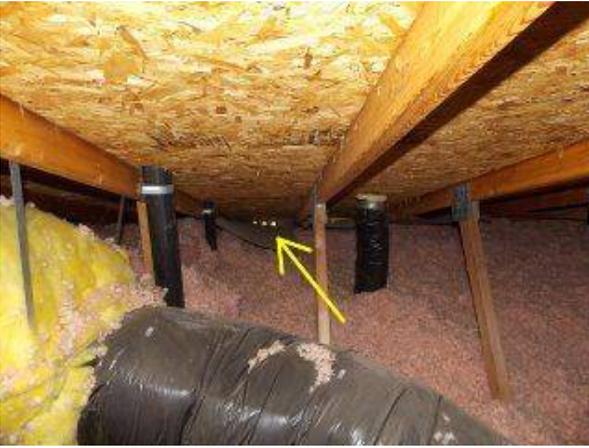
**Photo 17-1**

Cardboard baffles that are intended to keep insulation from blocking soffit vents in the attic were loose and had fallen down. Attic and/or roof structure ventilation can be reduced as a result. The service life for the roof surface materials can also be reduced because of high temperatures. Moisture from condensation is also likely to accumulate in the roof structure and/or attic and can be a conducive condition for wood-destroying organisms. Recommend that a qualified person repair or reattach baffles as necessary.

Fallen attic insulation baffle at east side.

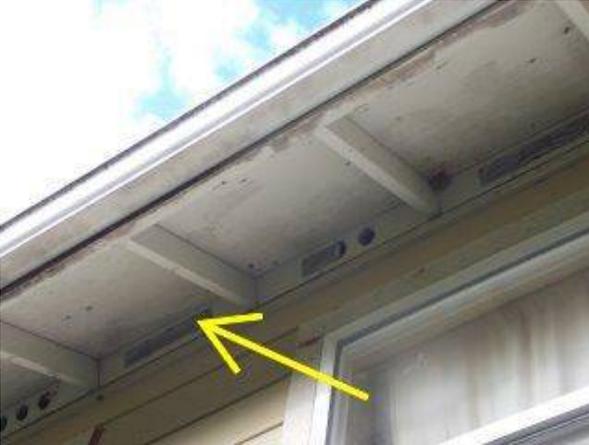
**Photo 18-1**

Some of the attic or roof vent screens were missing, deteriorated or substandard. Recommend that a qualified person replace or repair screens as necessary to prevent birds or vermin from entering the attic.

Tape obstructing vents and or some screens missing.

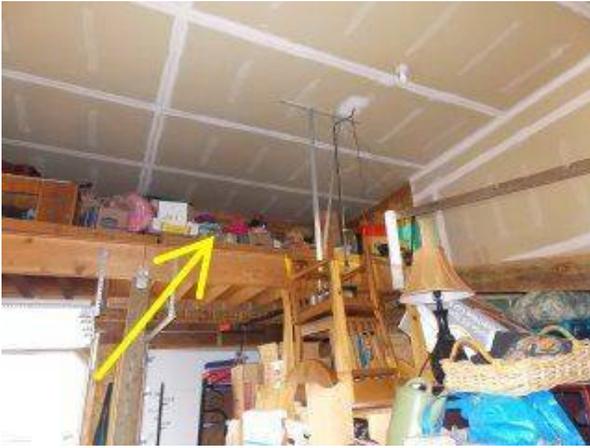
Garage deck landing, stairs, ramp and landing has no safety, guard or handrails. This is an unsafe conditions do to fall hazards. Recommend a licensed and qualified contractor do additional assessment and install or repair stairs, ramps and landings with proper standards.

**Photo 19-1**  
Garage landing fall hazard and many storage items.

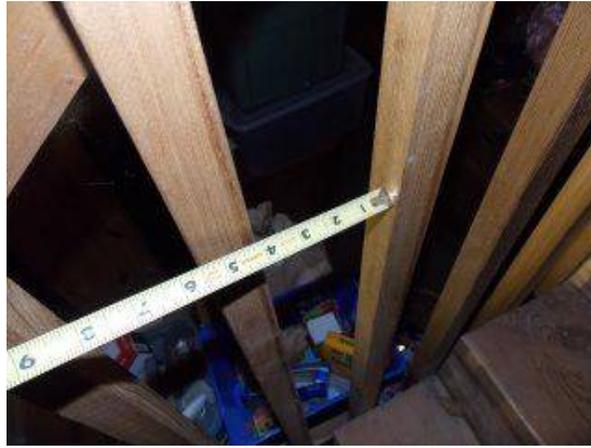
**Photo 19-2**  
Garage stairs picket spacing over 4"

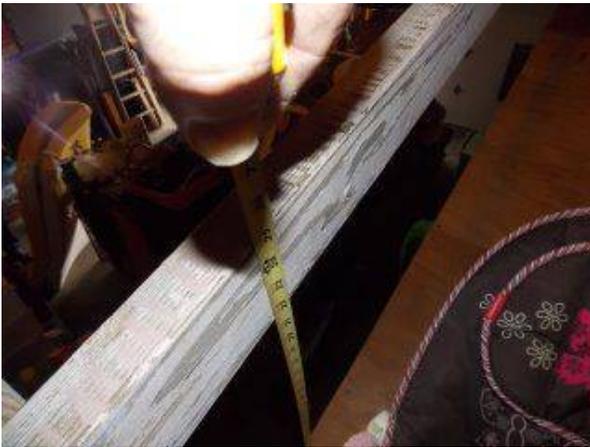
**Photo 19-3**  
Garage landing ramp rail @ 24" and no pickets.

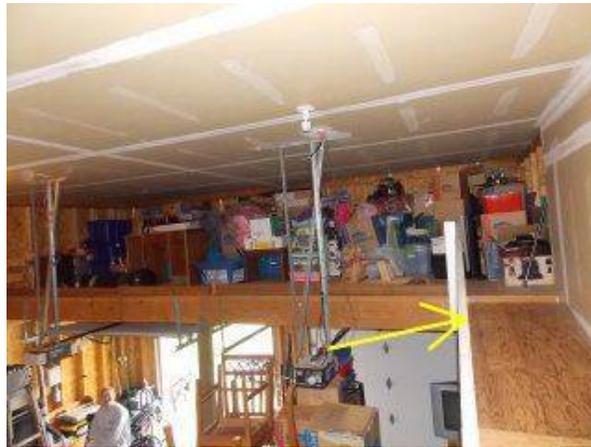
**Photo 19-4**  
Garage landing ramp has inadequate guardrails.

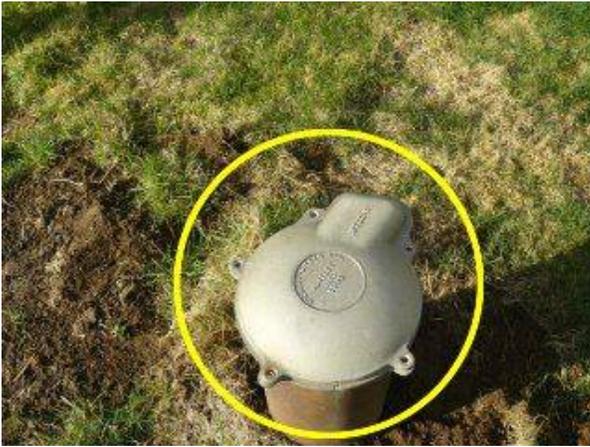
**Photo 21-1**

The inspector observed the well casing weather head is missing bolts. Based on visible equipment or information provided to the inspector, the water supply to this property appeared to be from a private well. Private well water supplies are specialty systems and are excluded from this inspection. Comments in this report related to this system are made as a courtesy only and are not meant to be a substitute for a full evaluation by a qualified specialist. The inspector does not test private well water for contamination or pollutants, determine if the supply and/or flow are adequate, or provide an estimate for remaining life of well pumps, pressure tanks or equipment. Only visible and accessible components are evaluated. Recommend the following:

Missing bolts at well weather head

- That a qualified well contractor fully evaluate the well, including a pump/flow test
- That the well water be tested per the client's concerns (coliforms, pH, contaminants, etc.)
- Research the well's history (how/when constructed, how/when maintained or repaired, past performance, past health issues)
- Document the current well capacity and water quality for future reference

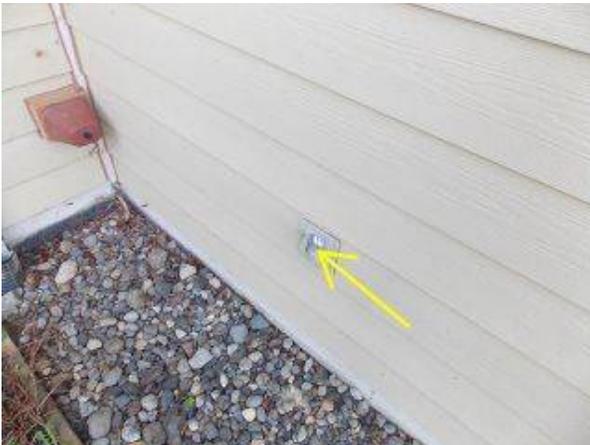
**Photo 25-1**

Exterior receptacle (outlet) covers were broken. This is a potential shock hazard. Recommend that a qualified person replace covers where necessary.

Weather cover broken

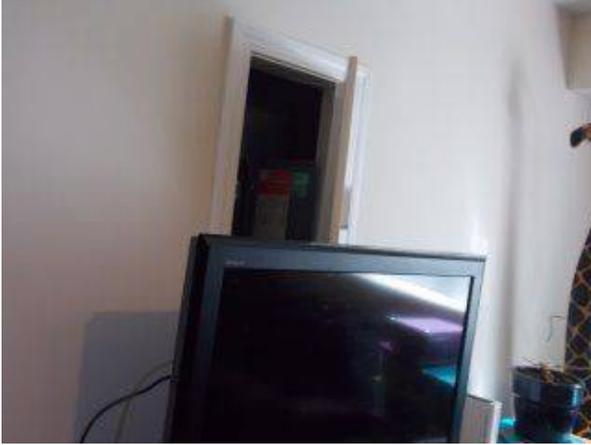
**Photo 27-1**

The inspector was unable to open and evaluate the Main electrical service panel, #A located in basement (East Wall) because items were blocking access. This panel is excluded from this inspection. Recommend that repairs, modifications and/or cleanup should be made as necessary so panels can be opened and fully evaluated.

Could not open service panel do to wall framing and trim.

Blocked main service panel cover.

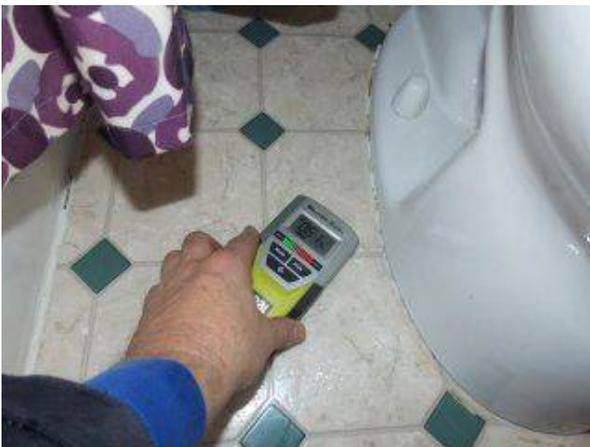
**Photo 34-1**

Elevated moisture readings at floor around toilet in upper bath.

Meter reading over 20%

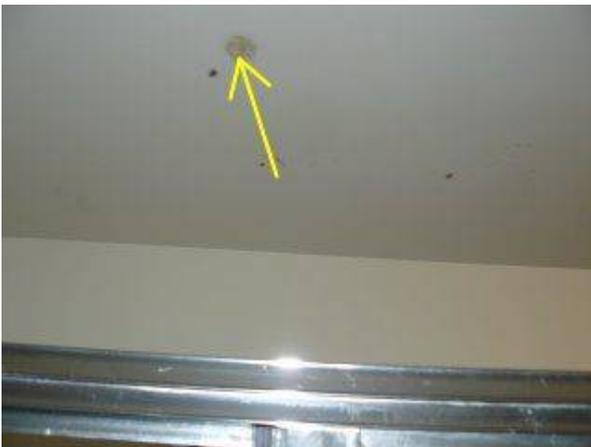
Photo 37-1

Stains from mold (fungus) and elevated levels of moisture were found in the down stairs 3/4 bath ceiling areas. This is a conducive condition for wood inhabiting conditions. The stains appear to be due to a past leak. Recommend that a qualified contractor evaluate and repair as necessary.

Lower bath water stains and elevated moisture readings.
